Particle Physics Division

Mechanical Department Engineering Note

Number: MD-ENG-339

Title: Corrosion Tests on Aluminum Samples

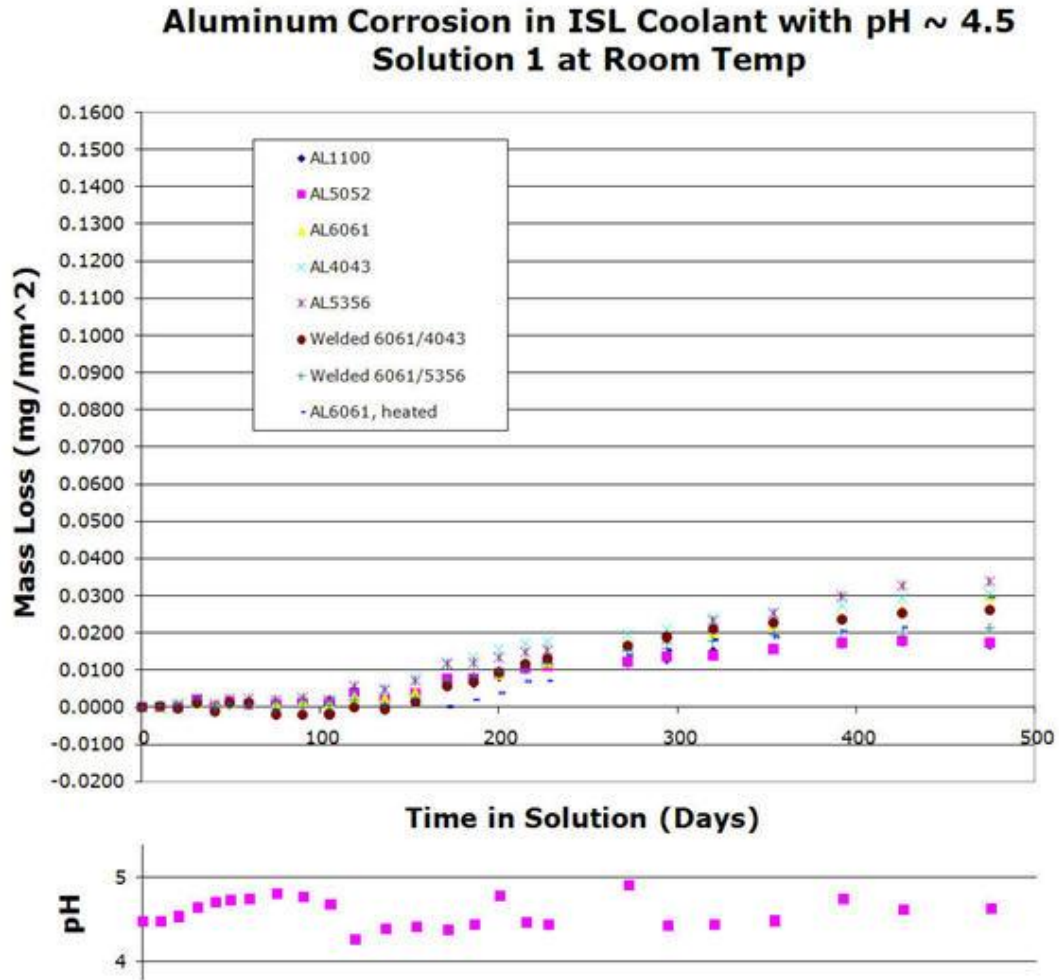
Chart 1. Mass Losses for Aluminum Samples in Solution 1

Mass Loss checks were done on all the aluminum samples that were immersed in Solution 1, 2, 2p, and 3 at room temperature. As the sample sizes and shapes were quite different, mass loss per each surface sample area was used for the report. These results are plotted on Charts 1, 2 and 3 where Chart 2 consists of ISL coolant at pH about 2 with and without turbid participants (Solutions 2 and 2p). Also, in order to simulate the ISL cooling condition, many samples were placed inside a refrigerator with temperature about +6C after 75 testing days elapsed and its corresponding results were shown on the same Chart 2. Not sure what had happened on Solution 3, it lost its acidity after one week and became neutral. Attempt to restore its pH value by adding more formic acid was made but it returned to neutral again in a week. Mass losses on these samples in Solution 3 was thus not very much and its results is presented here for reference uses only.

Mass losses due to acid attack was generally quite even over the entire surface. For comparison purpose, same scales of the X- and Y-axis were used in Charts 1, 2 and 3. From these results, the following were observed:

- No apparent mass loss in the first 100 days when coolant was with pH ~ 4.5, then small mass loss appeared after.
- Mass loss was very severe when solution was very acidic at pH ~ 2.
- Mass loss rate was much slower when solution temperature was colder at +6C.
- Aluminum filler wire 5356 lost mass most.
- Referring to Table 1, it appeared mass loss occurred more in non-turbid solution than turbid solution. In particular, the ISL tubing sample 1100 H-14 placed in the non-turbid solution lost mass several times quickly than the regular sample 1100 which was placed in turbid solution. On another comparison, the loss difference between 6061 and heated 6061 was not apparent.

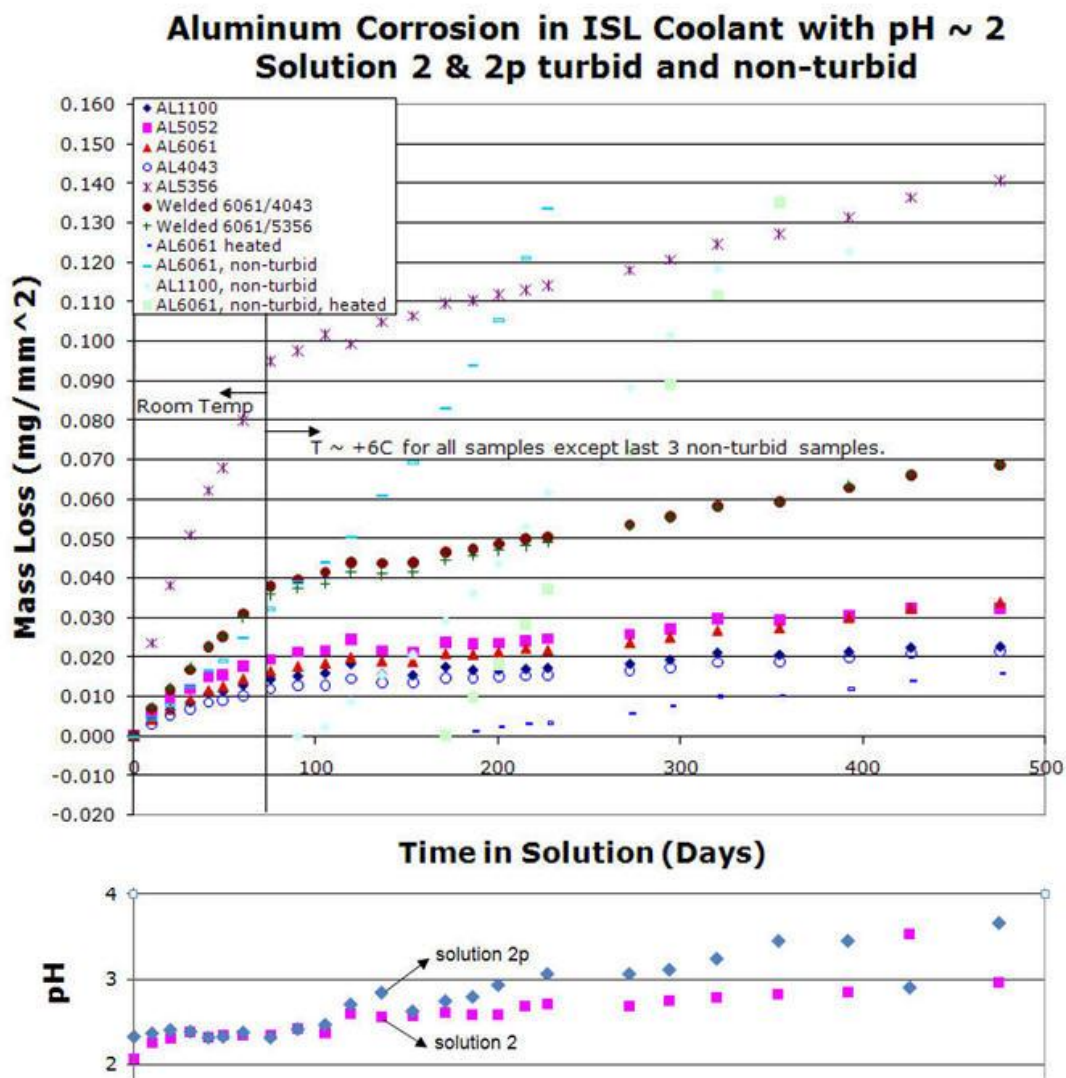
Chart 2. Mass Losses for Aluminum Samples in Solution 2 & 2p

The similar prism holder used in the ISL cooling line was placed in the non-turbid ISL coolant with pH about 2 (Solution 2p). This part was found dissolved completely after 42 days.

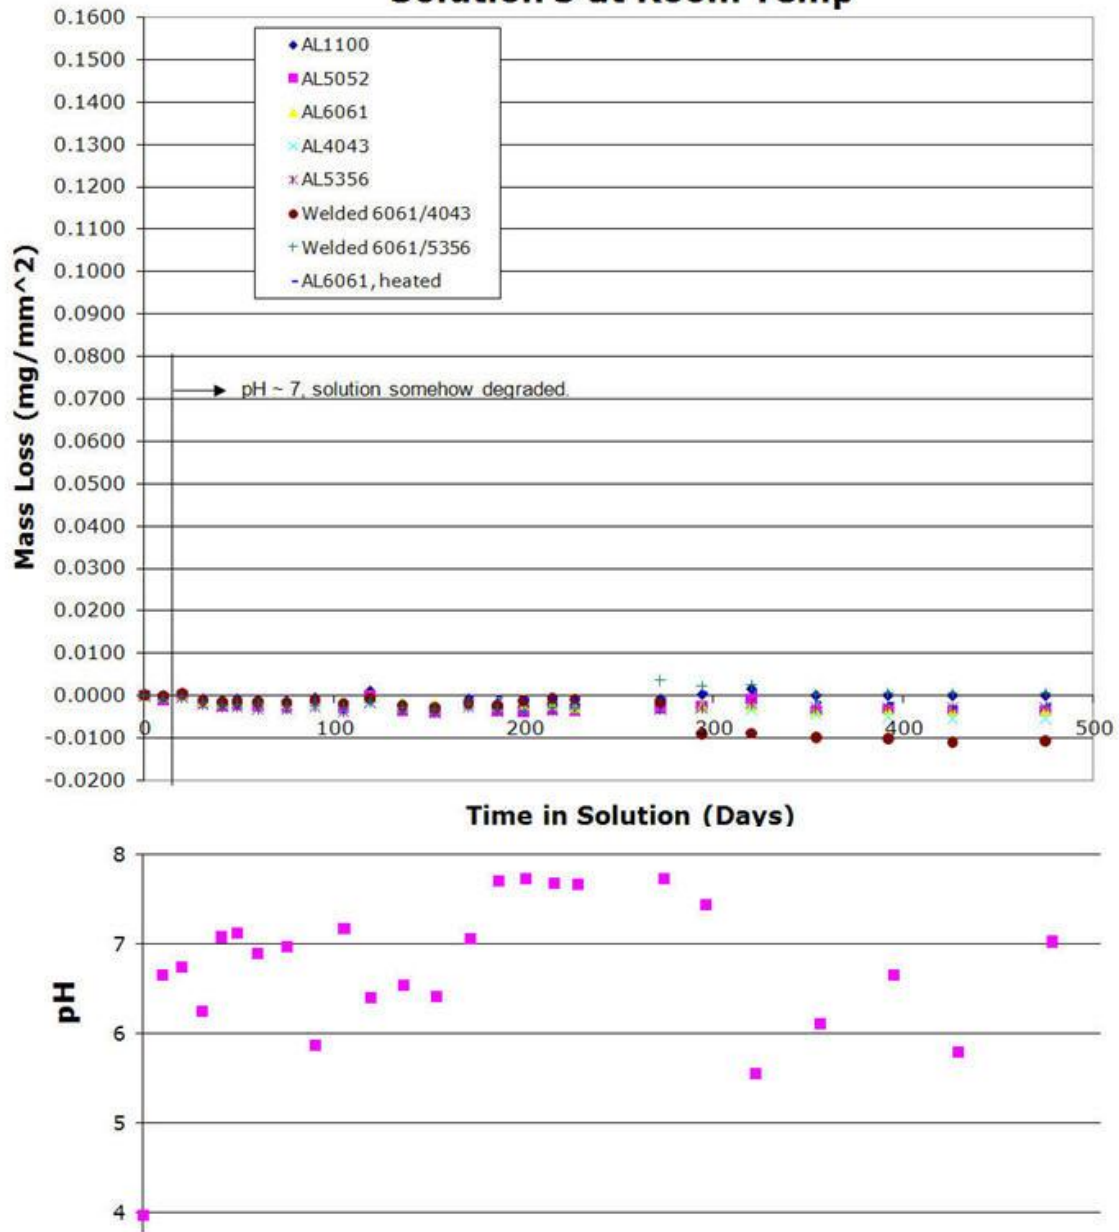
Aluminum Corrosion in Formic Acid with pH ~ 4.5 Solution 3 at Room Temp

Chart 3. Mass Losses for Aluminum Samples in Solution 3

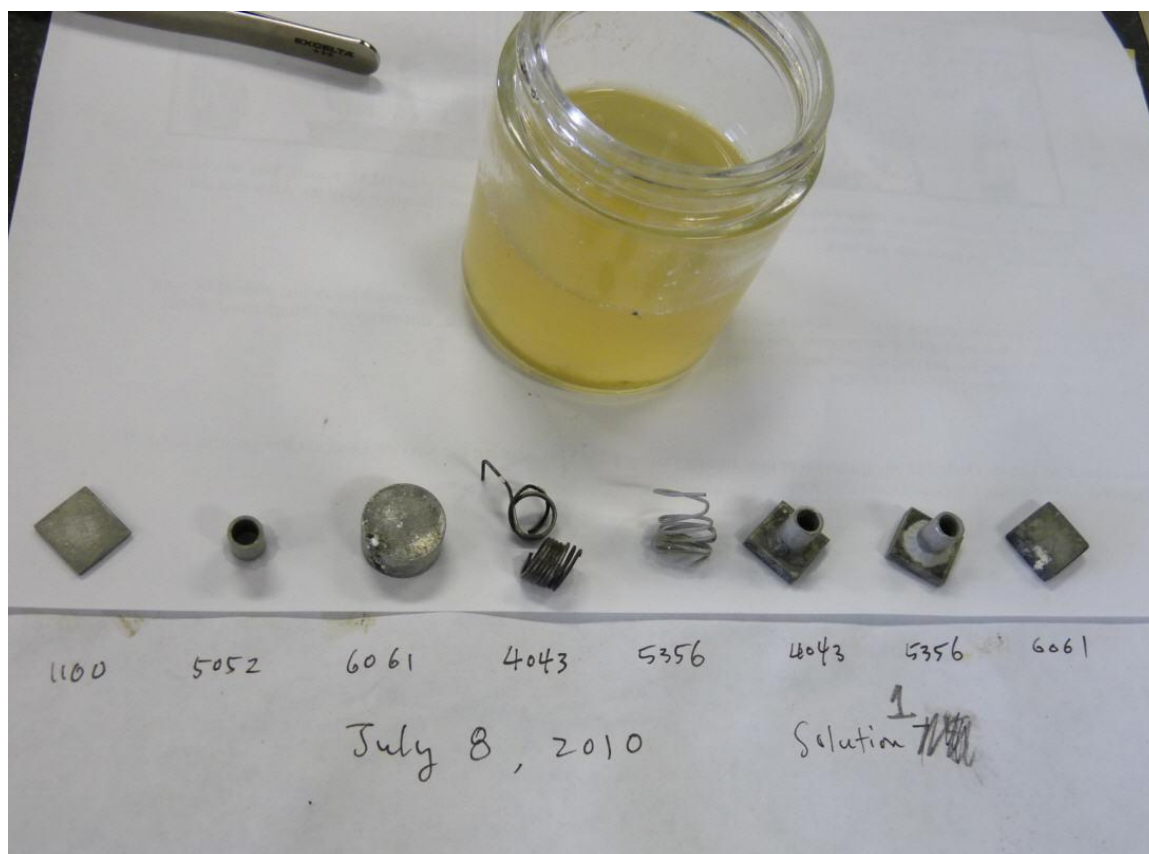
Figure 1. Aluminum Samples in Solution 1 after 1042 days

Pitting is the most common corrosion attack on aluminum alloy products. Pits form at localized discontinuities in the oxide film on aluminum. Since, in highly acidic or alkaline solutions, the oxide film is usually unstable and will suffer from general corrosion, pitting occurs only in a pH range of 4 to 9. It thus, pitting corrosion was expected to be happened in Solution 1 in which the pH was set about 4.5 but not in Solution 2. Signs of pitting with the gelatinous white corrosion products, which was supposed to be the alumina $\text{Al}(\text{OH})_3$ covering the pit, were first observed on aluminum welding filler wire 4043. It was so severe that it eventually broke the wire into 2 parts after 426 days. After 475 days, samples 1100, 6061 and welded assembly with 5356 were found with some slight pitting. However, pitting on these samples was stopped after the water rinsing step. Since the pitting corrosion appeared to be disturbed by the rinsing, it was thus decided no more rinsing and hence mass weighing were conducted because the major goal of the testing was to verify pitting corrosion but not general corrosion. After 1042 days, slight pitting was observed again on both samples 6061 (with and without heated). The final states of these samples were as shown in Figure 1.

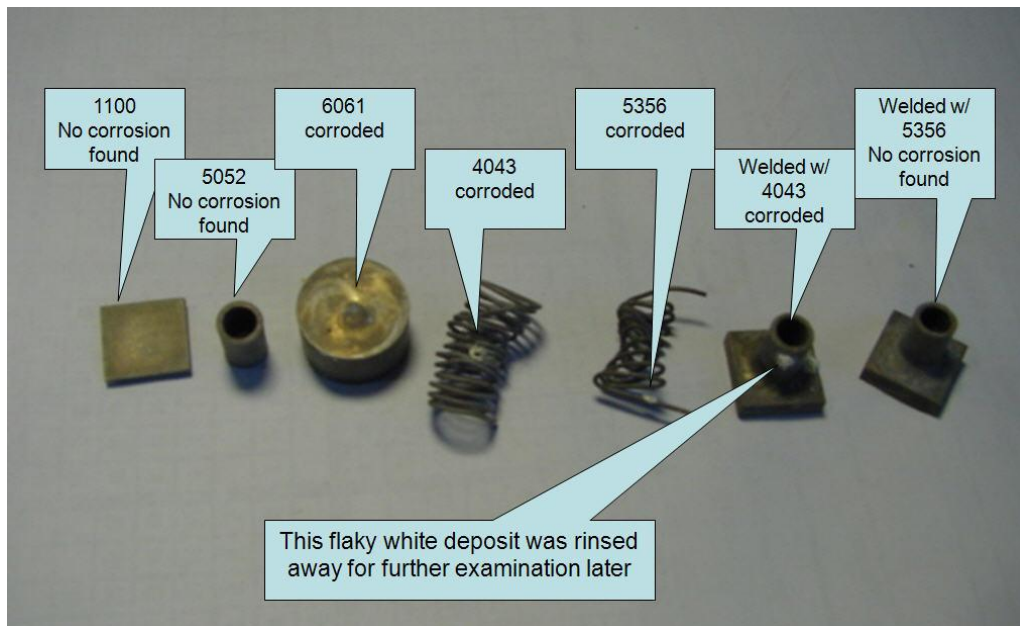
Figure 2. Aluminum Samples in Solution 3 after 171 Days

Pitting corrosion was actually first found on aluminum samples in Solution 3 which was fresh-made formic acid with a pH set at 4.5. The acidity of this solution was changed to neutral gradually and it kept this neutrality although attempt was made in trying to put it back its acidity after two weeks. The unintentional neutrality of this solution thus provided the environmental condition for pitting corrosion to occur. First signs of pitting were observed after 136 days. Pitting on these aluminum samples was clearly envisioned after 171 days as shown in Figures 2, 3, 4 and 5 in which it showed pitting corrosion on 6061, 4043, 5356 and welded aluminum assembly with filler wire 4043. The white deposits on the welded assembly were removed and the aluminum was inspected further under microscope. The rim of the pit appears to be irregular as shown in Figure 6. With the focal dimensions obtained on the rim and on the bottom of pit, the depth of the pitting was estimated and it was about 360 microns. However, after this disturbance, all pitting corrosions including this one were found stopped even at the end of 1042 days.

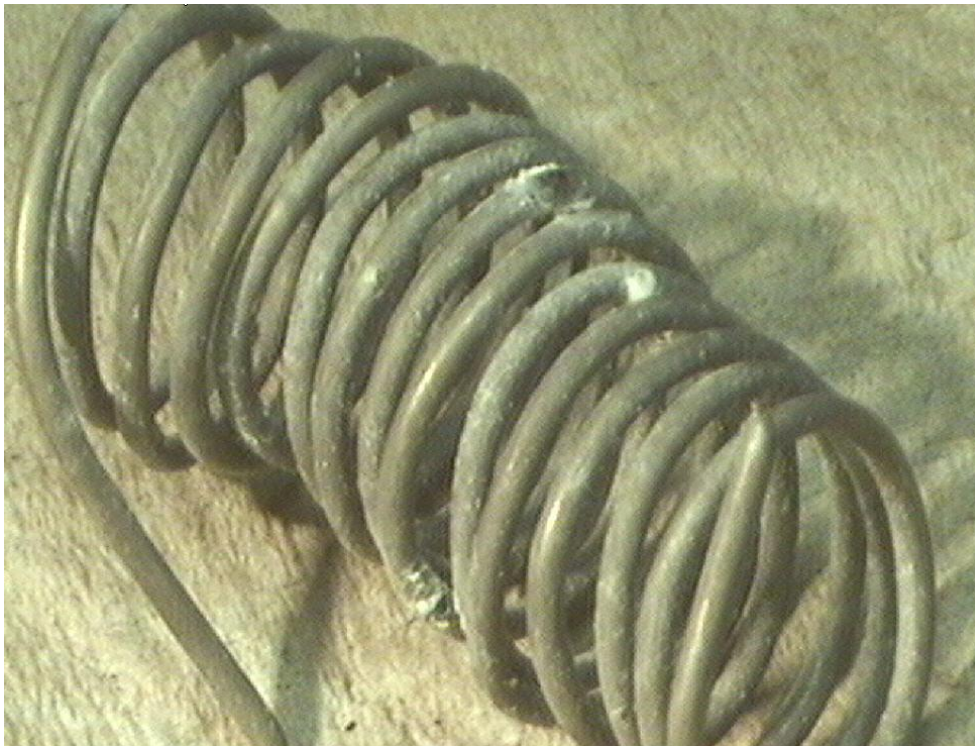
Figure 3. Aluminum Filler Wire 4043 in Solution 3 after 171 Days

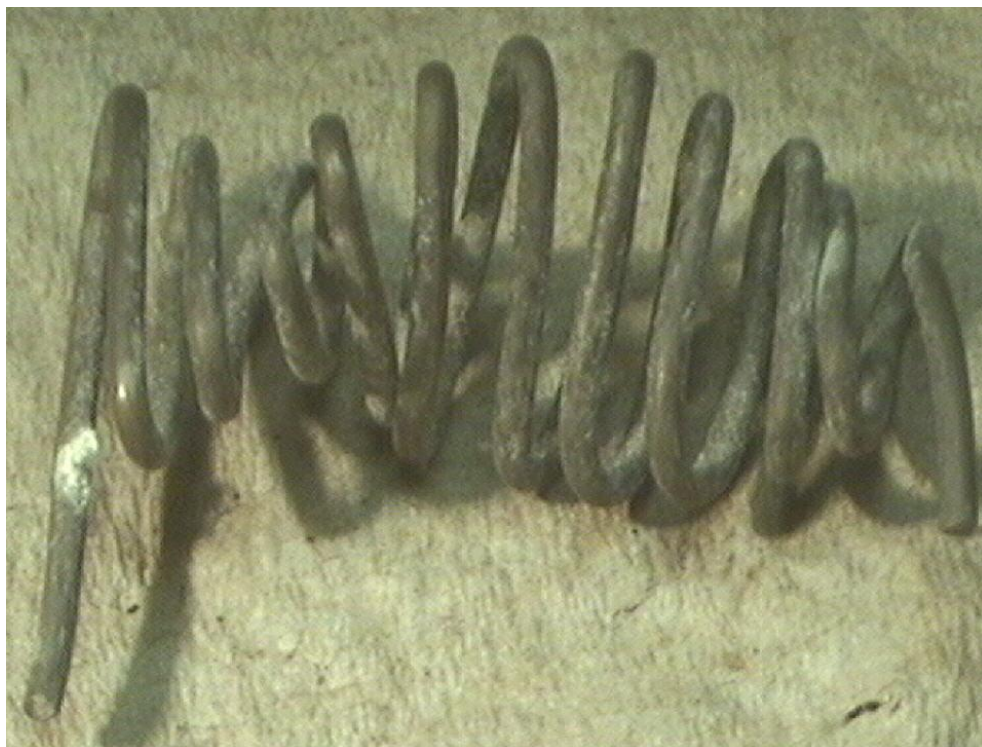
Figure 4. Aluminum Filler Wire 4043 Solution 3 after 171 Days

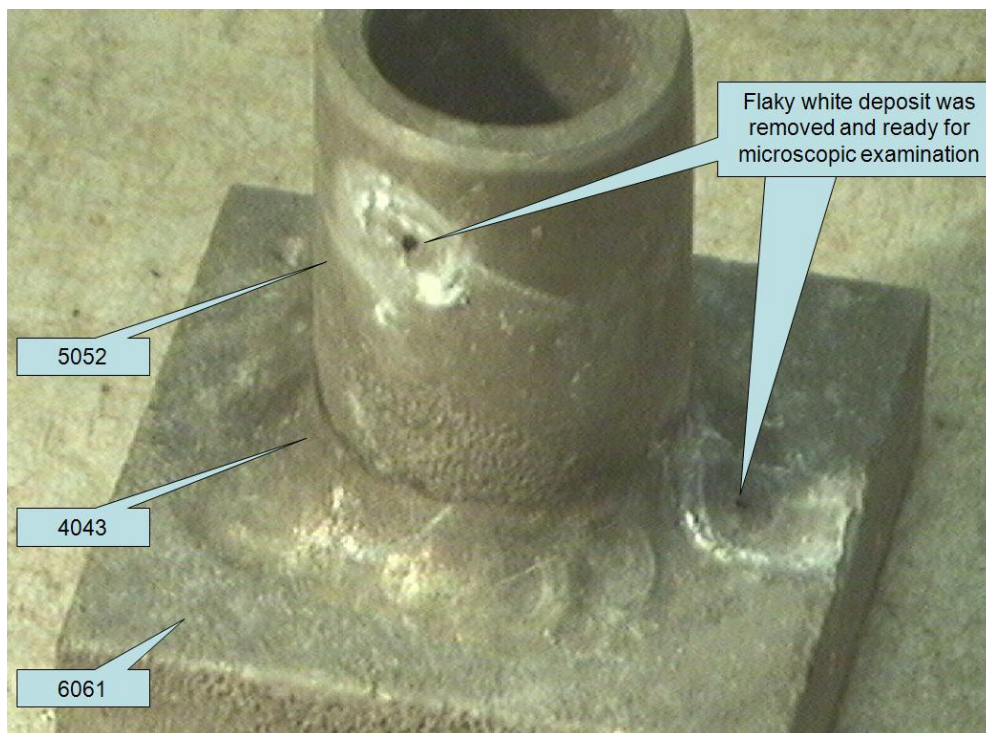
Figure 5. Aluminum Welded Assembly in Solution 3 after 171 Days

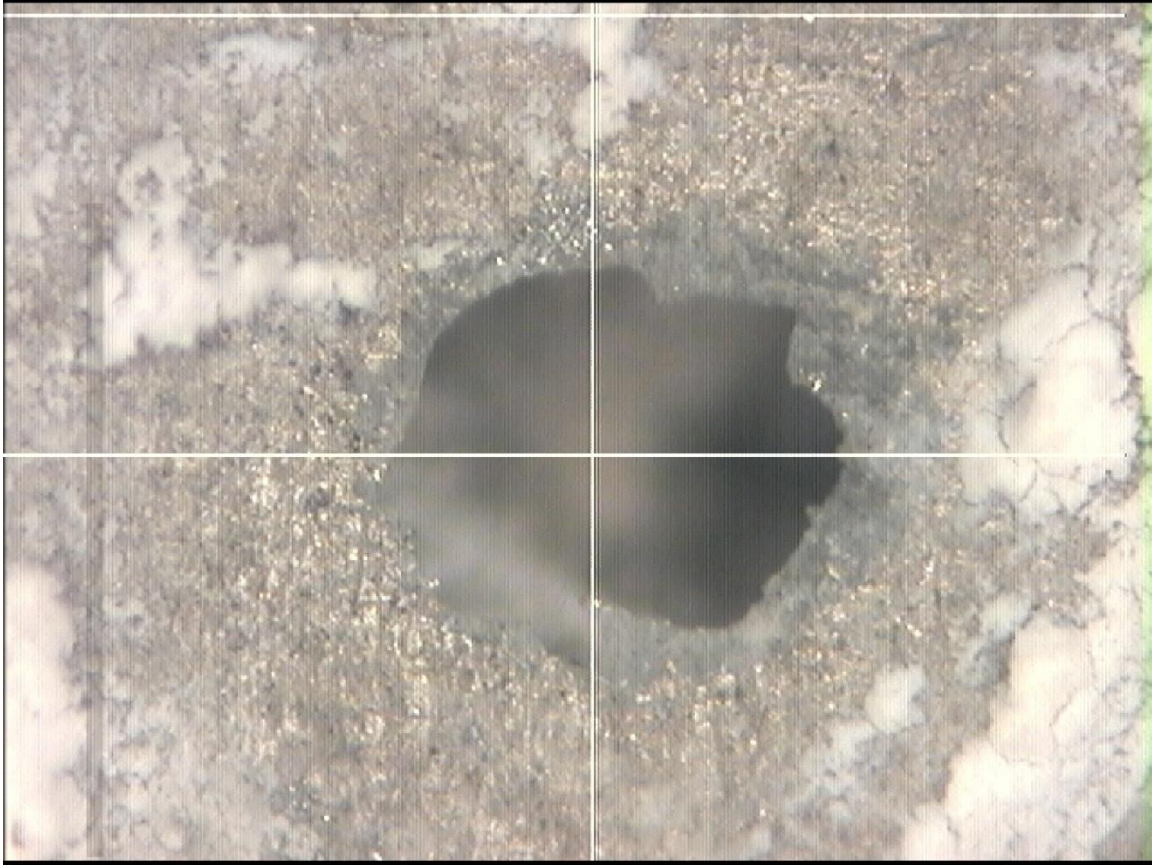
Figure 6. The Pit on Aluminum Welded Assembly in Solution 3

It thus, pitting corrosion was happened in stagnant Solution 1, Solution 3 and Solution 7 in which the pH was between 4 to 9. Aluminum 5052 on its own proved to be the most corrosion resistant and never got any pitting corrosion. Others pitted for a period but stopped. Aluminum filler wires 4043 and 5356 on their own were not that corrosive resistant. They performed reasonably well in the welded assemblies though as the pitting locations were found in the base parts but not on the weld bead.

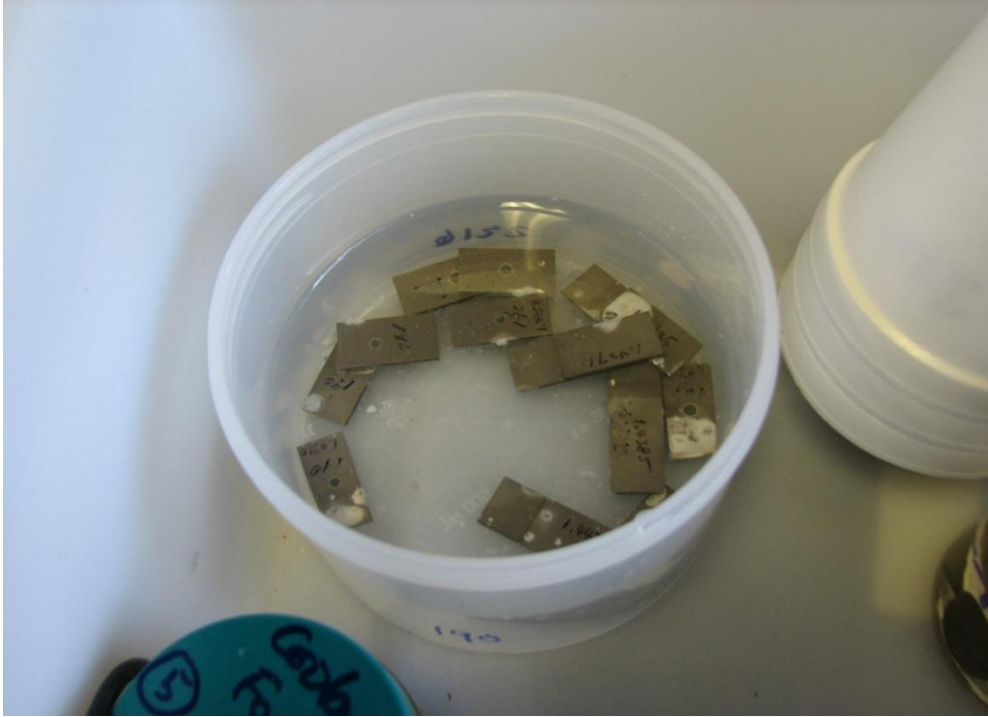
Figure 7. Aluminum Epoxy Sample in Water after 25 Days

Pitting corrosion was also found for those epoxy-glued-aluminum 1100 samples in water (Solution 7 with pH ~7). It was started after 25 days and remained this state at the end of 1042 days as shown in Figures 7 and 8.

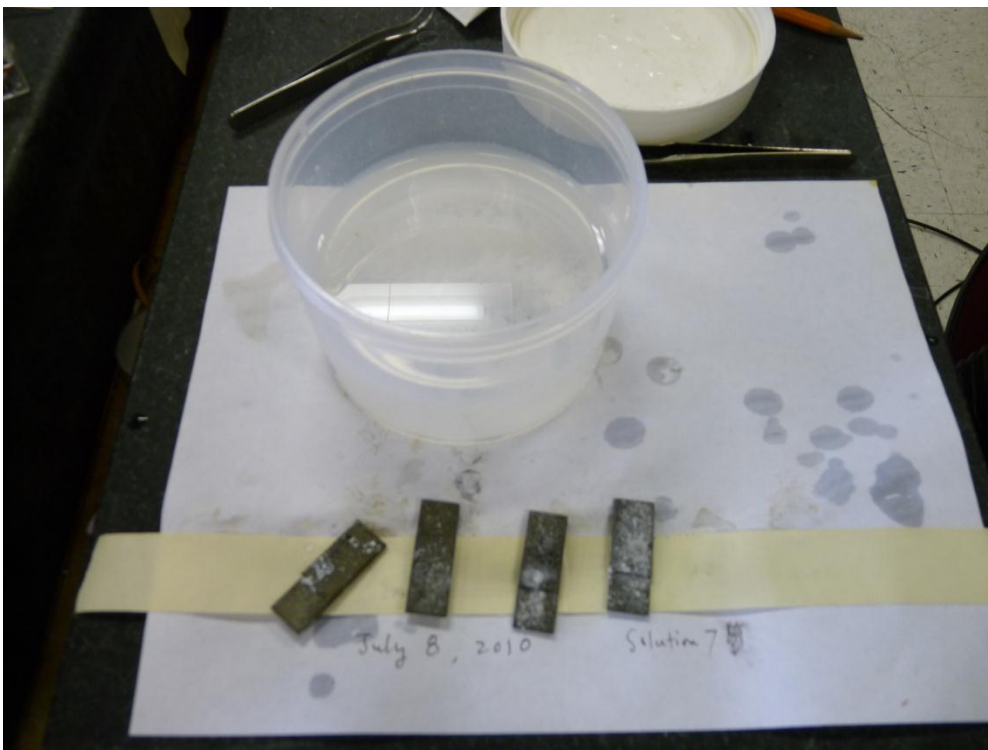
Figure 8. Aluminum Epoxy Sample in Water after 1042 Days

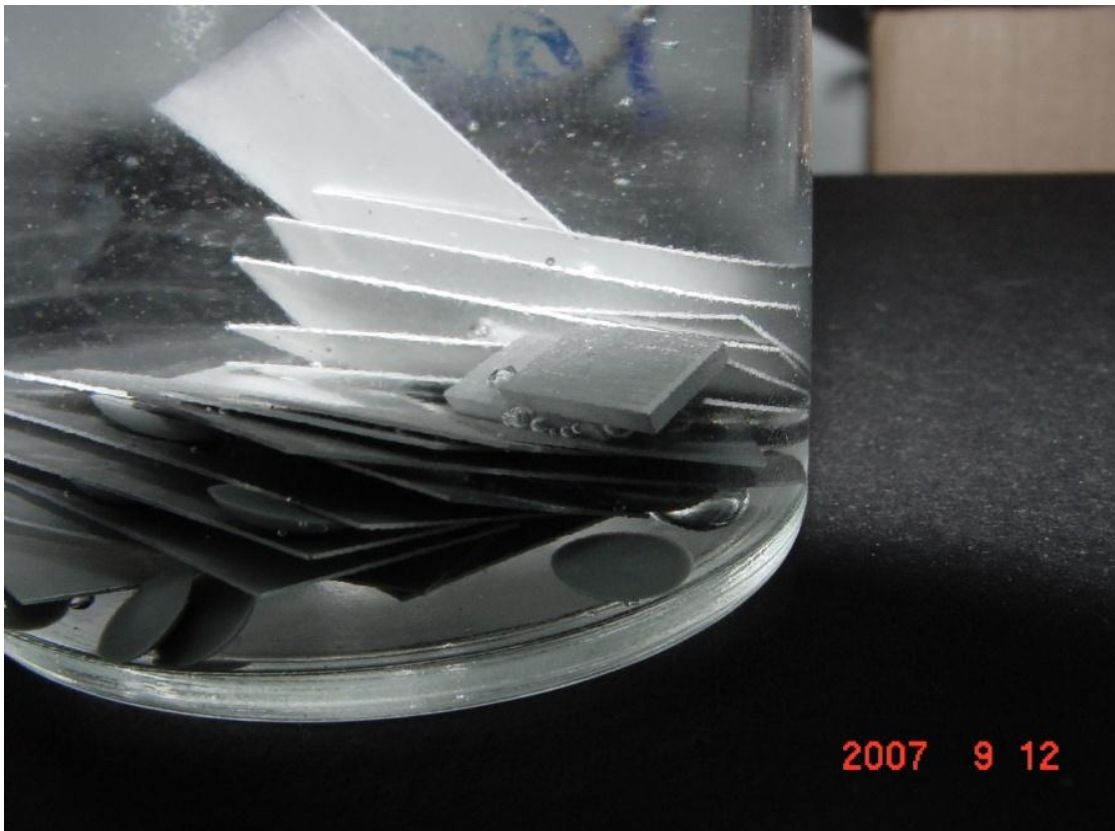
Figure 9. Aluminum Epoxy Sample in Solution 4 after 10 Days

Three kinds of solution were used. The first one was the formic acid (Solution 4), the second one was ISL coolant (Solution 5) and the last one was distilled water (Solution 7). The first two solutions were started with a pH about 2 but both gradually increased to 4. Many bubbles, supposedly to be hydrogen, were generated from the samples after 10 days as shown in Figure 9. Droplets of epoxy samples were also seen clearly detached in this figure. Solution 4 turned into turbid after 2 months and with huge amount of white corrosion precipitations. On the other hand, Solution 5 remained reasonably clear through this 3-year testing period. On the other hand, the epoxy samples in distilled water were definitely survived much longer in this mild condition without detachment. The number of days that the samples found detached in these 3 solutions was compared as shown in Table 2.

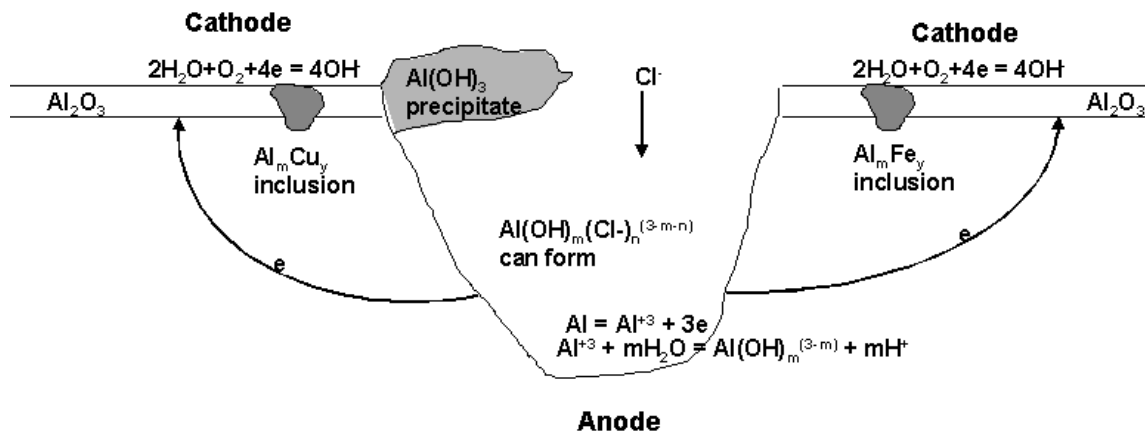
With reference to ref. 5, a generalized picture of the propagation of a pit in aluminum in aerated solutions containing chloride ions is shown in Figure 10. The pH of the environment is assumed to be in the range of about 5 to 9.

Figure 10. General Pitting Corrosion when Chloride Ions are presented

Though the exact mechanism of aluminum pit initiation depends on the actual alloy type, some general characteristics of the process can be summarized as follows.

- Microflaws exist in the aluminum oxide layers that provide passivity to the alloy. The surface is very likely a hydroxide form of aluminum.
- **The chloride adsorption in the microflaws, if any, might aid in pit initiation.**
- Alloys of aluminum contain intermetallic compounds can form dissimilar metal junctions at the surface. For example, 2000 series aluminum contain copper aluminide inclusions and 3000 series aluminum contain iron-aluminide inclusions. The copper aluminide inclusion may decompose to redeposit copper on the surface.
- A potential difference is created between the "unflawed" aluminum surface and that created by pre-existing flaws, chloride adsorption in flaws, or the intermetallic inclusions.

- As a result of the potential difference, oxygen reduction on the "unflawed" surface or on the intermetallic compound drives the anodic dissolution in the region of the flaw or on the aluminum surface adjacent to the intermetallic compound.

The result is a micropit. Some of the micropits repassivate. Some propagate to larger pits. The above figure shows the process as the pit is propagating. The propagation process has the following characteristics.

- Aluminum dissolution proceeds within the pit especially at the bottom or base of the pit.
- Aluminum ions react with water (hydrolysis) to form aluminum hydroxide cations and hydrogen ions.

- The formation of hydrogen ions decreases the pH relative to the environment outside of the pit further accelerating the dissolution process.
- **In a chloride environment, chloride ions increase in concentration to maintain charge neutrality. These ions can react with the aluminum hydroxide ions to form chloride containing adducts.**

- Aluminum hydroxide can precipitate at the pit-environment boundary. Sometimes this hydroxide can cover the pit surface but maintain electrolyte contact between the pit and environment.

- Hydrogen ions can be reduced to form hydrogen gas bubbles.
- Oxygen reduction continues on the surface as the cathodic driver. In addition, copper from the copper-aluminide intermetallics at the surface can be reduced further driving the process.
